GAI CONSULTANTS INC MONROEVILLE PA
NATIONAL DAM INSPECTION PROGRAM. RECREATION DAM (NDS ID NUMBER --ETC(U)
MAR 79

PHASE I REPORT
National Dam Inspection Program
Abstract

Recreation Dam (Cold Stream Dam): NDS I.D. No. PA-00446

<u>Owner:</u>	Borough of Philipsburg
<u>State Located:</u>	Pennsylvania (PennDER I.D. No. 14-26)
<u>County Located:</u>	Centre
<u>Stream:</u>	Cold Stream
<u>Inspection Date:</u>	14 and 22 November 1978
<u>Inspection Team:</u>	GAI Consultants, Inc. 570 Beatty Road Monroeville, Pennsylvania 15146

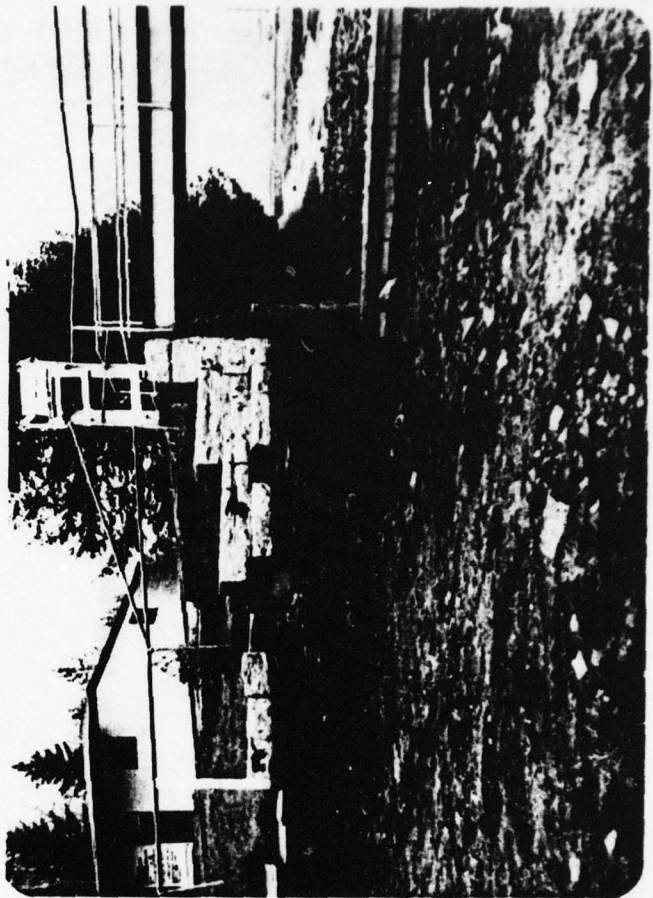
According to PennDER files, the spillway has required considerable maintenance over the years, consisting mainly of repointing the masonry joints and replacing the flashboard support pipes. Many of the joints require repointing at this time and there is severe cracking along the left spillway wingwall (see Photograph 8).

Based on visual observations, the spillway is considered to be in poor condition. The left abutment wingwall is cracked and missing several stones. Much of the mortar is loose or missing from joints along the ogee-like section. In addition, a large scour hole has developed downstream of the left spillway bay. The reservoir was, in fact, drained prior to the inspection because of concern over the present condition of the spillway.

Photograph 8 Closeup view of the left wingwall of the spillway.

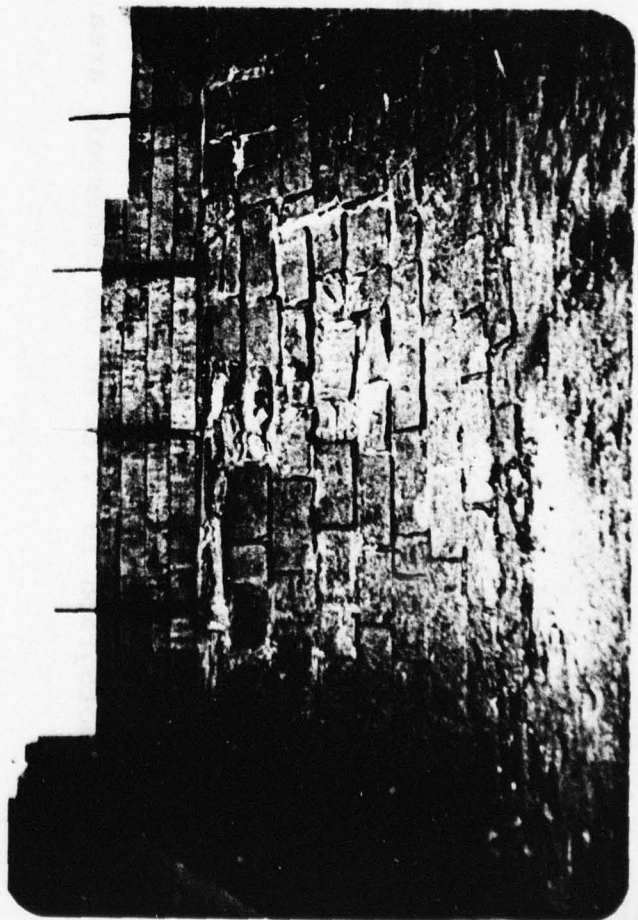
There are no operations or maintenance manuals for the facility. Trees and bushes have become established on the slopes. The iron pipes supporting the remaining flashboards are deteriorated as are portions of the spillway. These above-listed deficiencies suggest a lack of maintenance. There are no formal warning systems in effect at the site.

Photograph 7 Closeup view of the downstream face of the masonry spillway showing the deteriorated condition of the spillway and flashboard supports.

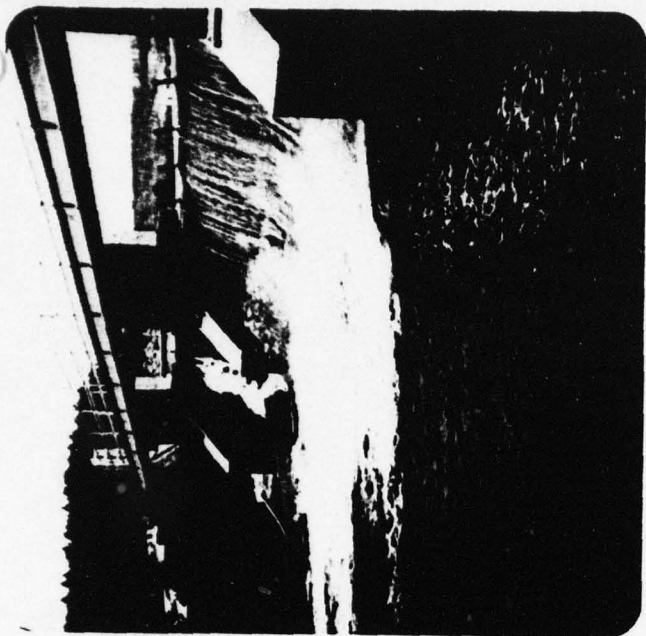
Photograph 5 Photograph from PennDER files showing view of the spillway as it appeared in March 1978. Note that the flashboards are in place.

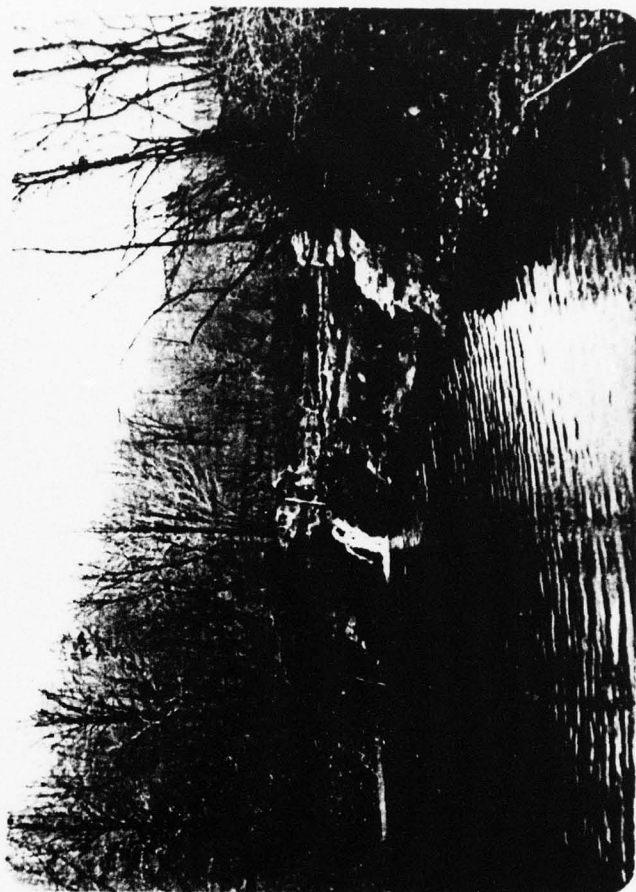
12

View of a dilapidated dam located just downstream of the Philipsburg Reservoir. The dam still impounds a small amount of water.
